A technical investigation of an oil painting on copper support, including a study on consolidants for treatment

Dissertação para obtenção do Grau de Mestre em
Conservação e Restauro, especialização em pintura

2. Condition report

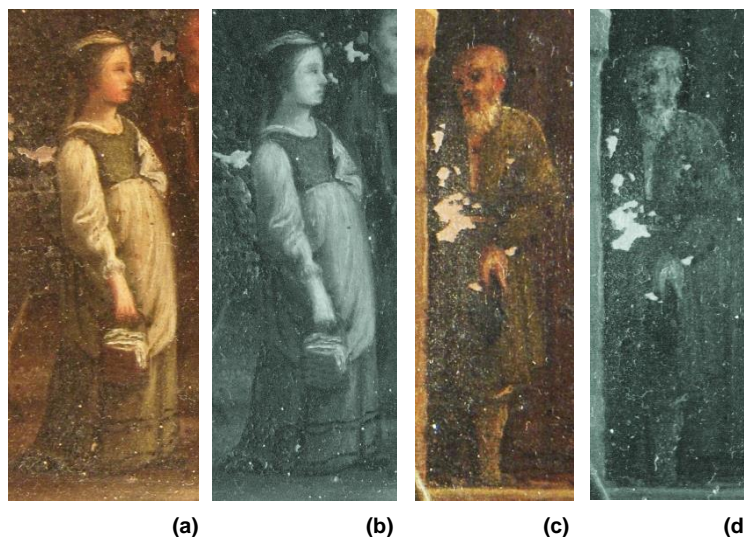
Figure 2 –Detail of the maid: (a) normal light; (b) in infrared (IR). Detail of Zachariah: (c) normal light; (d) IR.

2 c & d). This painting's style of representation, with an impressive amount of well executed minute details filling the whole composition, is thought to be Flemish (16th/17th century)².

All three figures (Mary, Joseph, and Elizabeth) are depicted plainly, without halos, and dressed in traditional costumes. On the other hand, both the maid and Zachariah are dressed with garments belonging to a certain epoch (see Fig. 2 a–d), determined to be the second half of the 16th century by costume experts Dr. Xénia Ribeiro and Dr. Dina Dimas³. For the maid, indicators are her dress with a high waistline; the veil which covers her head partially; and her hair style. As for Zachariah, features

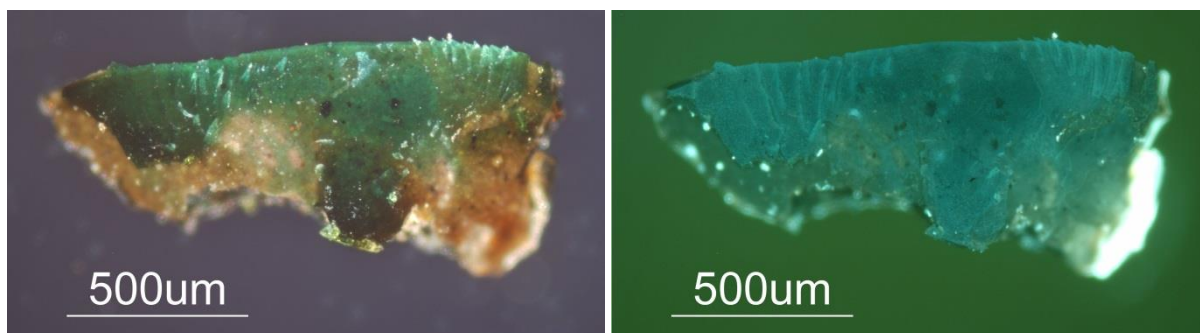
Figure II.7 – Underside of paint fragment in normal light (left) and Filter set 5 (BP 395-440, FT 460, LP 470) for fluorescence (right) (x50).

3. A significantly thicker, vivid green layer was observed on only one paint fragment thus far (see Appendix II, Fig. II.7). Its thickness has not been measured due to the fragment not being in cross-section. It appears to be on top of the paler green, thinner one described above (most commonly found), but it is not clear if the first is an evolution of the second. Like the green layer, it does not fluoresce under UV light, and it does not coat the underside of the fragment evenly. But unlike the green layer above some of it was left behind on the copper surface when the fragment was collected, indicating that the substance can fracture within the layer itself (lack of internal cohesion), and

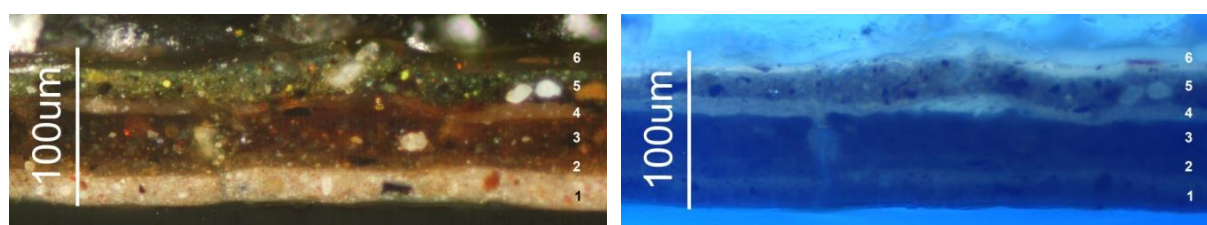
Figure IV.2 – Cross-section S1, photographed in OM with normal (left) and UV light (right), with layers numbered (x200). Layer 5 is considered to be overpaint since it is sandwiched between two layers of varnish, 4 and 6.

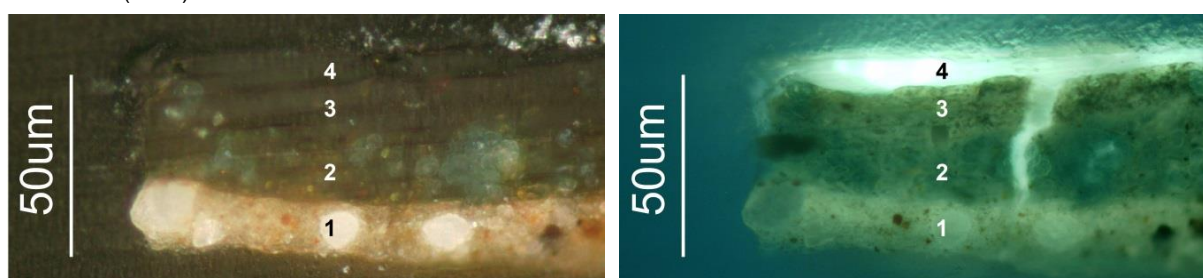
Figure IV.6 – Cross-section S5 (original), photographed in OM with normal (left) and Filter set 5 (BP 395-440, FT 460, LP 470) for fluorescence (right), with layers numbered (x500).

The most striking feature of this painting regarding its condition is the drastic difference in the state of the paint between darker colour areas (primarily in the foliage) and the remaining colours (blues, greens, beiges/browns, flesh tones, and reds). In every area where the paint is currently dark (it is unclear whether it has undergone change, or was very dark to begin with) severe mechanical cracking with associated flaking is observed. In these areas the paint islands resulting from mechanical cracking exhibit an extremely low level of adhesion to the support, are very brittle, and are slightly cupped (see Appendix II, Fig. II.9). It is also very “lumpy” in terms of texture; it has a high concentration of small vivid green circles protruding at the surface (see Appendix II, Fig. II.10 and II.11), which were later characterized to be composed of atacamite or paratacamite (see Section 3.2), and it seems to have a higher amount of binder (oil) in comparison to the other colours, as this was evident in cross-section under the microscope (see Appendix IV.3, Fig. IV.6).

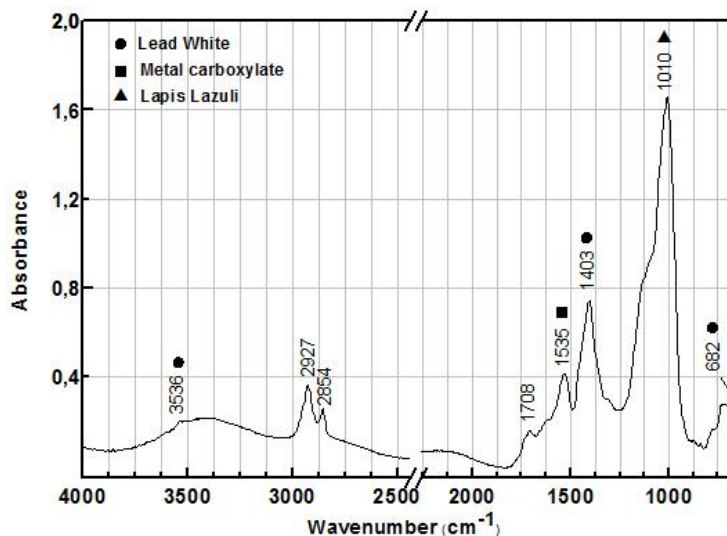
Figure IV.16 - μ -FTIR spectrum of paint sample.

The illustrative spectrum to demonstrate analysis of the paint binder was acquired from a sample collected from the sky area (blue paint). The bands at 2927 cm^{-1} , 2854 cm^{-1} (CH_2 stretching), and 1708 cm^{-1} ($\text{C}=\text{O}$ stretching) indicate the presence of a drying oil [1; 2]. The bands at 3536 cm^{-1} ($\text{O}-\text{H}$ stretching), 1403 cm^{-1} (CO_3^{2-} asymmetric stretching), and 682 cm^{-1} (CO_3^{2-} in plane rocking) are related to lead white ($2\text{PbCO}_3 \cdot \text{Pb}(\text{OH})_2$), also detected by μ -Raman in the same blue layer (see Appendix IV.4, Table IV.4, S2) [2]. The intense band at 1010 cm^{-1} ($\text{Si}-\text{O}-\text{Si}$ and $\text{Si}-\text{O}-\text{Al}$ overlapping stretching) reveals the other pigment present in the blue paint, ultramarine blue ($(\text{Na},\text{Ca})_8[(\text{SO}_4,\text{S},\text{Cl})_2](\text{AlSiO}_4)_6$), probably of natural source (lazurite, extracted from lapis-lazuli) [1]. FTIR also detected a band at 1535 cm^{-1} (COO^- asymmetric stretching) which is indicative of a metal carboxylate, most probably a lead soap [3].

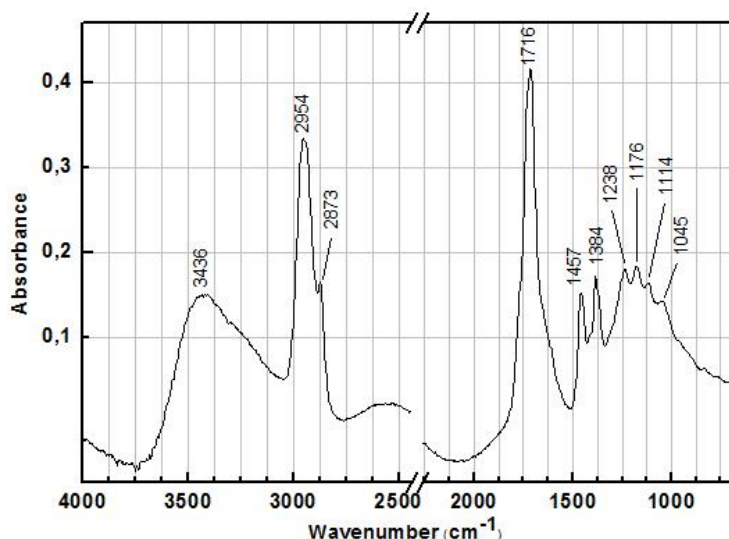
Figure IV.17 - μ -FTIR spectrum of varnish layer.

The two strong and distinctive bands at 2954 cm^{-1} and 2873 cm^{-1} (CH stretching), and at 1716 cm^{-1} ($\text{C}=\text{O}$ stretching) indicate the presence of a triterpenoid resin, either dammar or mastic [1]. The remaining bands also indicative of this type of resin are between 1457 and 1384 cm^{-1} ($\text{C}-\text{H}$ bending); 1238 and 1045 cm^{-1} ($\text{C}-\text{O}$ stretching); and at 3436 cm^{-1} ($\text{O}-\text{H}$ stretching) [1].

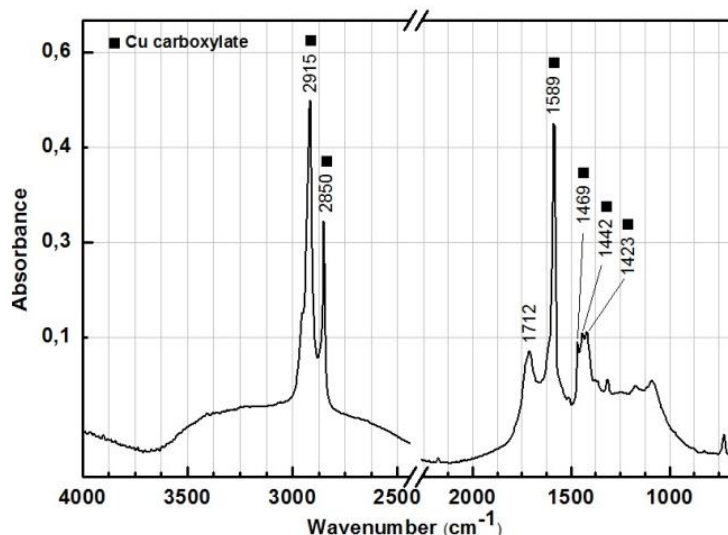
Figure IV.18 - μ -FTIR spectrum of green interfacial translucent layer.

The distinctive bands at **2915 cm^{-1}** (CH_2 asymmetric stretching); **2850 cm^{-1}** (CH_2 symmetric stretching); **1589 cm^{-1}** (COO^- asymmetric stretching); and the less intense ones at **1469 cm^{-1}** (CH_2 bending); **1442 cm^{-1}** (CH_2 bending); **1423 cm^{-1}** (COO^- symmetric stretching); and **1315 cm^{-1}** (CH_2 bending) all indicate a copper carboxylate [3; 4]. The band at **1712 cm^{-1}** (C=O stretching) indicates the presence of carboxylic acids within the oil matrix (formed during its drying process) [2].

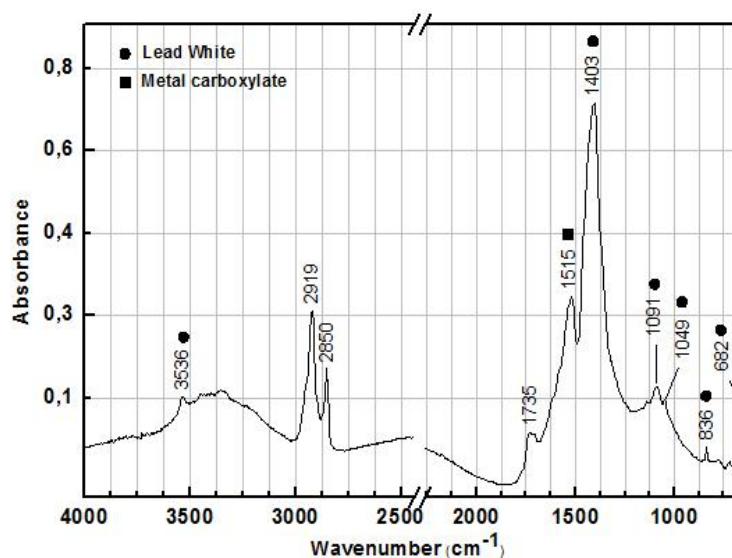
Figure IV.19 - μ -FTIR spectrum of white-grey layer found covering the copper support.

The bands at **3536 cm^{-1}** (O-H stretching), **1403 cm^{-1}** (C-O stretching), **1049 cm^{-1}** (CO_3^{2-} symmetric stretching), **836 cm^{-1}** (CO_3^{2-} out of plane rocking), and at **682 cm^{-1}** (CO_3^{2-} in plane rocking) all indicate the presence of lead white ($2\text{PbCO}_3 \cdot \text{Pb(OH)}_2$) [2]. The two distinctive bands at **2919 cm^{-1}** and **2850 cm^{-1}** (CH_2 stretching), indicate the presence of a drying oil [1], along with the ones at **1735 cm^{-1}** (C=O stretching of ester bond) and at **1091 cm^{-1}** (C-O ester). The shift of the 1735 cm^{-1} band towards a lower wavenumber (from 1744 cm^{-1} , the value of the same absorption for an unaged drying oil) indicates that this binder has aged at least through hydrolysis [5]. The band at **1515 cm^{-1}** (COO^- asymmetric stretching) further indicates a metal carboxylate, most probably a lead soap [3].

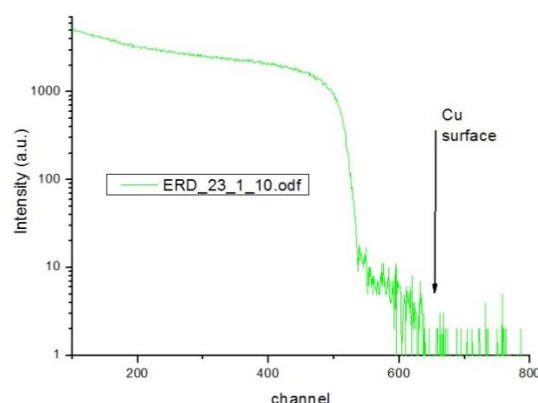
Figure V.4 – RBS spectrum for coupon 23.

The spectrum indicates Cu diffusion from the substrate up to the surface of the polymeric film, with a well-defined film thickness area.
